FLOOD RESISTANT HOUSING

LOW-COST DISASTER-RESISTANT HOUSING IN BANGLADESH

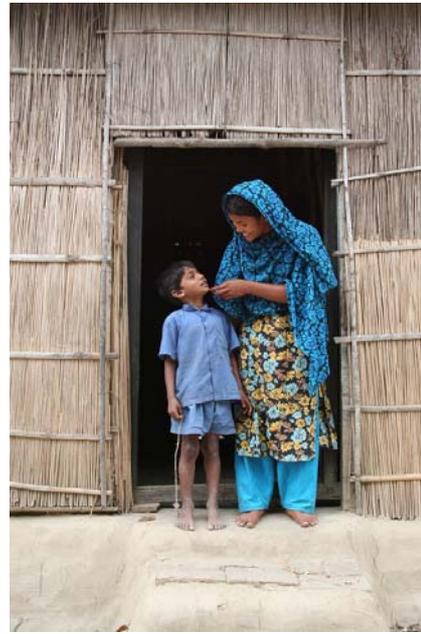
Figure 1: Hosne Ara (14 yrs) and Faruq Hussein (10 yrs) live with their parents in Wazuddin Fakirer Dangi, The house is built on a raised plinth made from sand, clay and cement. Photo: Practical Action Bangladesh.

The house is built on a raised plinth made from sand, clay and cement (meaning it is less likely to be washed away in floods), and made using concrete pillars and treated bamboo poles. Strong and high enough to last through repeated floods, unlike the traditional earthen floors that simply wash away.

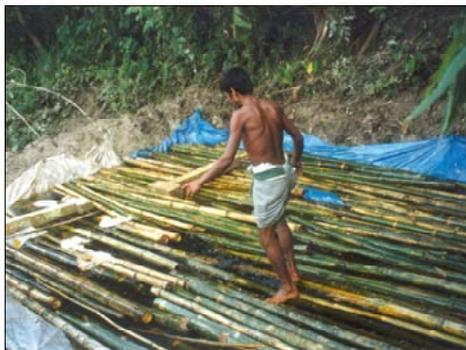
Figure 4: Curing bamboo trees for building Flood proof houses Faridpur, Bangladesh. Photo: Practical Action Bangladesh.

Bamboo poles are treated to make them more resilient to flooding so that they last longer.

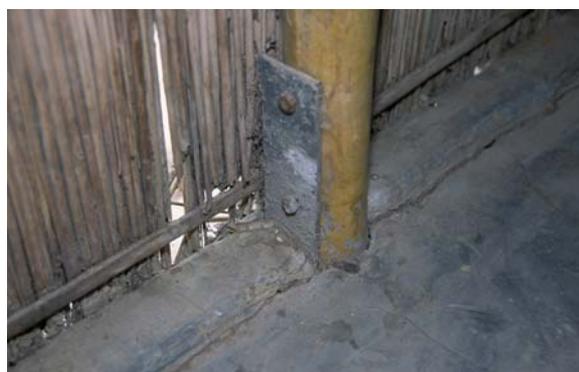
Figure 5: detail of the footing. Photo: Practical Action Bangladesh.

Reinforced concrete posts with footings were introduced to strengthen the structure. Short reinforced concrete stumps for the treated bamboo posts make the structure more resilient to the water.

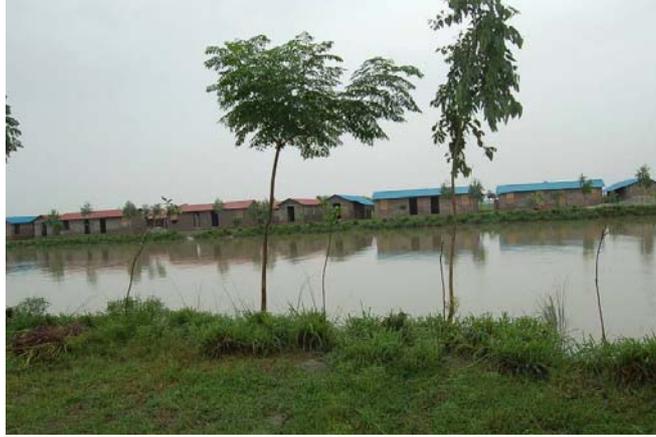
Figure 6 : A completed cluster village with pond for community fish culture. Photo: Practical Action Bangladesh.

The cluster village is made in a collaborative way; people excavate soil and sand from one area to build an earth platform. This is done in the dry season December to April. The hole where the soil/sand is excavated from creates a reservoir which is used by the community for various livelihood initiatives such as fish farming, duck rearing, floating gardens etc.

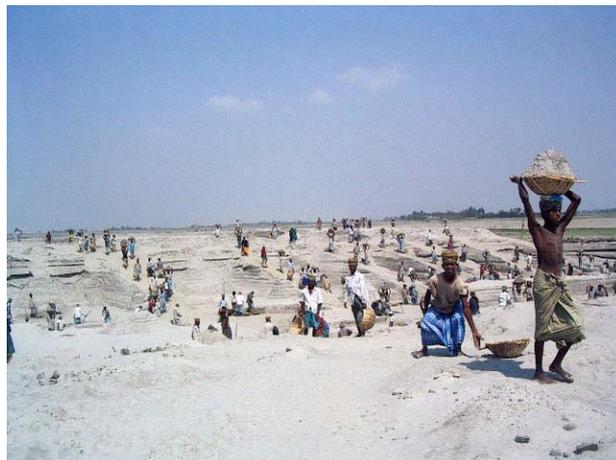
Figure 8: The whole community work together to make a large raised platform for the cluster village. Photo: Practical Action Bangladesh.

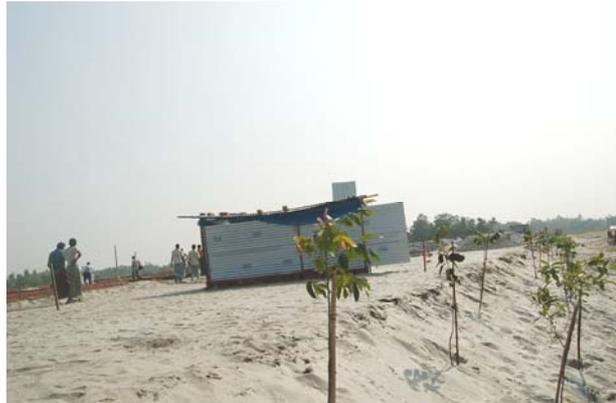
Figure 9: The newly finished earth raising is planted with young trees to stabilise the sandy soil. Photo: Practical Action Bangladesh.

The banks are stabilised by planting fruit trees and Napier grass (which can also be used as goat/sheep fodder).
