THE SRI LANKAN PUMPKIN TANK

A CASE STUDY

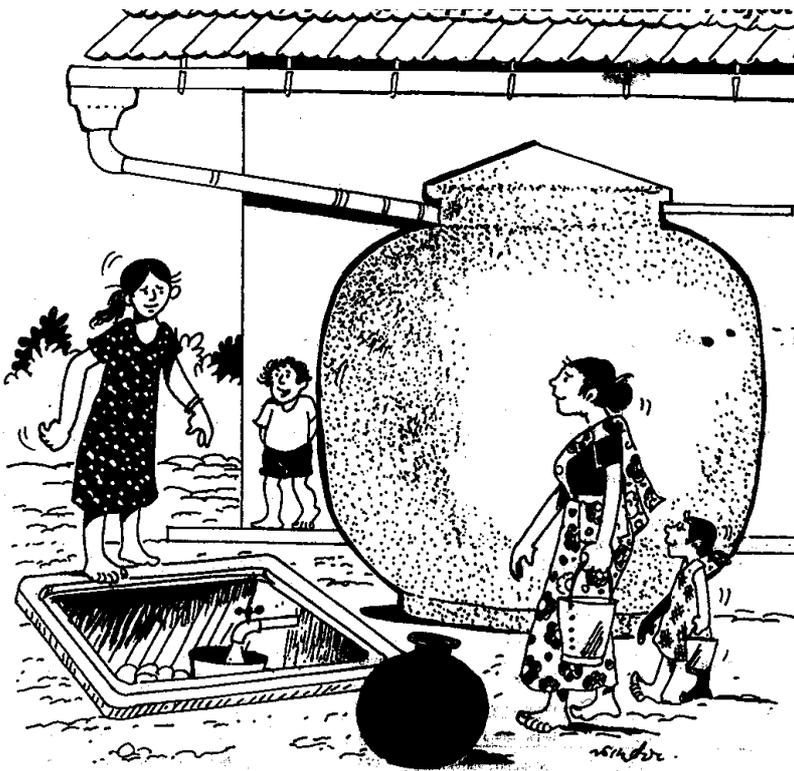
Figure 1: The Pumpkin water tank

This pumpkin tank was built 3 years ago and is in very good condition. The construction is of ferrocement. The construction detail is given later. The cost of the tank is approximately SLR5,000 or Sterling £77.00. The materials and specialist labour for the tank were provided by CWSSP and the guttering was purchased by the Abikon family.

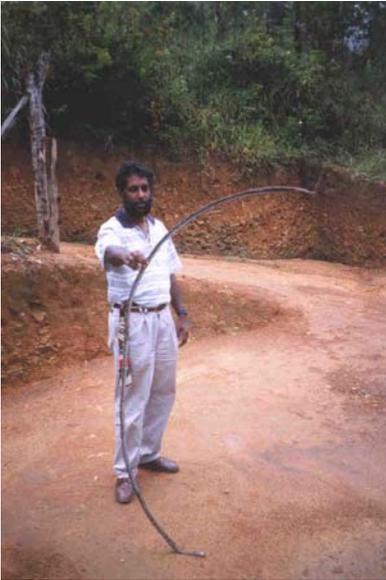
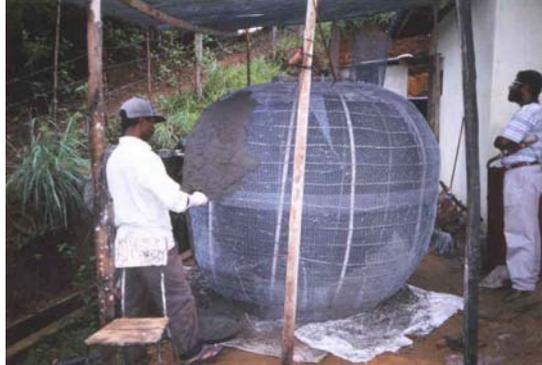
Figure 2: a) One of the 10 legs used to form the skeleton frame. b) The skeleton frame being rendered.

1. Prepare skeleton / framework legs (Figure 14) as shown in the drawing. 10 no. required. Prepare the crown ring. This can be used again for many tanks.
2. Lay the concrete base using two layers of chicken wire as reinforcing. Allow 300mm of chicken wire to protrude all around the edge of the base. This will be connected to the

- wall mesh later. Lay 10 anchor bolts for the legs in the base while casting (the diameter will depend on the diameter of the holes in the legs).
3. Leave the base for 7 days to cure, wetting each day.
 4. Secure the 10 skeleton legs using the bolts and the crown ring.
 5. Take 6mm steel rod and wrap it around the outside of the legs, starting at the bottom and working up at 10cm intervals.
 6. Fix 2 layers of chicken wire over the outside of the skeleton. The filter tower can be added at this point if a filter is to be fitted.
 7. Plaster the outside of the mesh. Leave for 1 day.
 8. Go inside the tank and remove the skeleton.
 9. Plaster inside the tank and cure for 7 days.

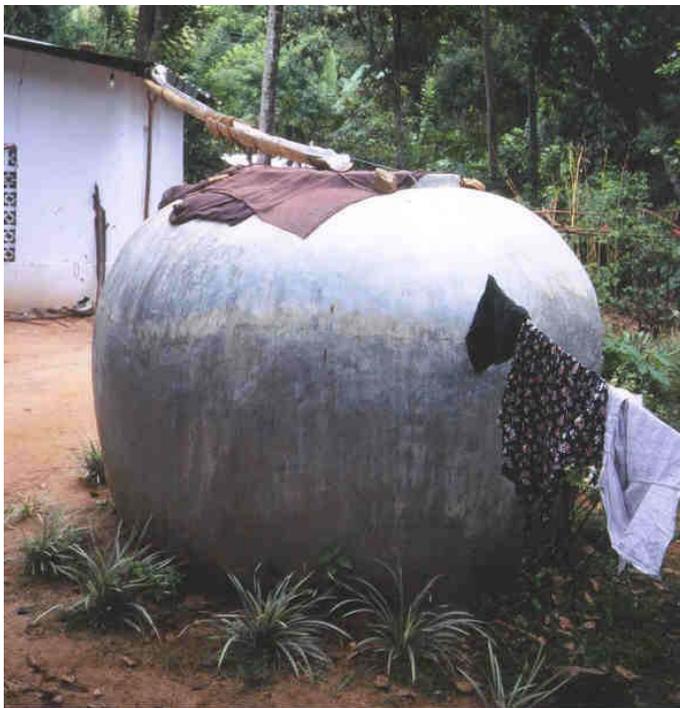
Figure 3: A finished Pumpkin tank
